Manhole Inspection Summary

Manhole # S06AA2017MH

Insp Date: **9/29/06 8:36 AM**

Location Address: **3801 FALLSTAFF RD**

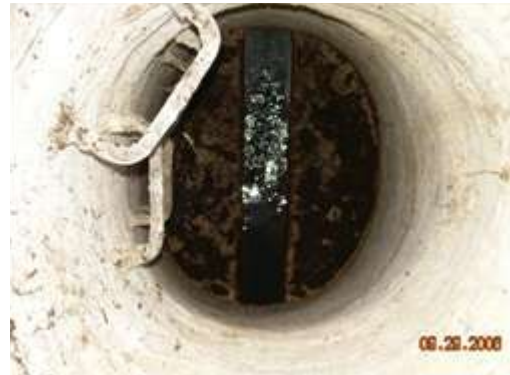
Top View

Adjustment infiltration. Evidence of surcharge - Bench debris.

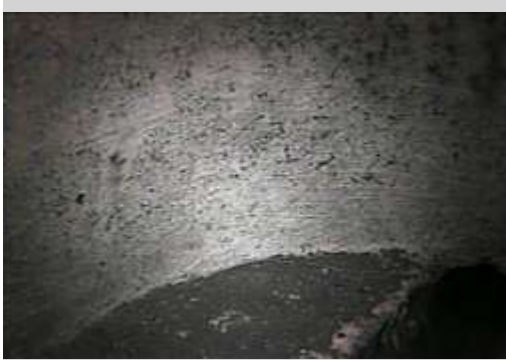
Defect

Bench debris.

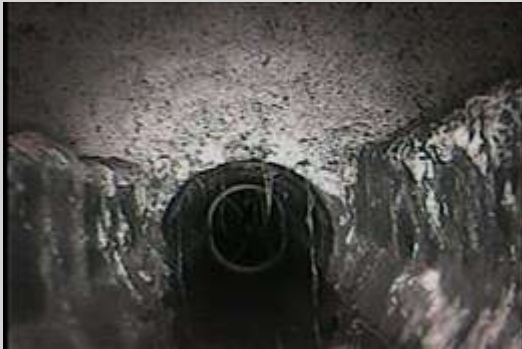
8 in. Circular Gravity Sewer Pipe Out @ 12 O'Clock

Infiltration: **Evidence** Pipe Seal Cond: **Roots**

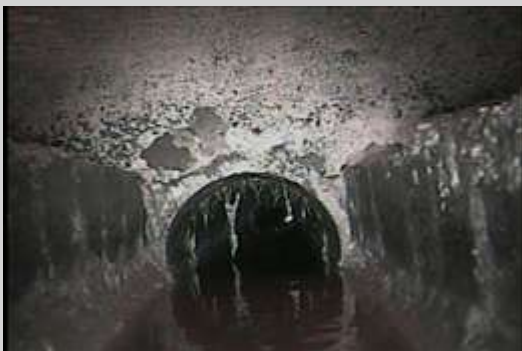
8 in. Circular Gravity Sewer Pipe In @ 6 O'Clock

Infiltration: **Evidence** Pipe Seal Cond: **Unknown**
